Response to "1st batch of Qualification Lots"

Response	Subject;	>Look Ahead Qualification Assembly Results
Quinones/Cebu/Fairchild	Response to:	ച്ച 1st batch of Qualification Lots
	Category:	Wireless SO-8 Pkg Dev't (FEIP+CEIP Technology, Matrix Mold Thru- Gate Design)
	Keywords:	Wireless SO-8 Matrix Package Development

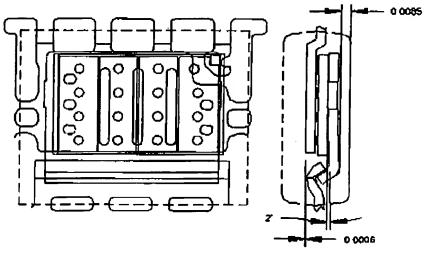
We have made some actual crossections on the units and the actual parts do not meet as per dimensional requirement. Pls discuss this with your Engg guys so we can correct on the 200K order. Pls confirm ASAP.

Drawing regit: Actual measurement: Clip angle 2 degrees 5 - 6 degrees Level difference 0.6 mil 2.6 - 2.8 mils bet, v-groove and pad

If we meet dimensions as per dwg, clearance from the clip to the mold pkg is 8.5 mils, currently this is very small as per actual cross-sections.

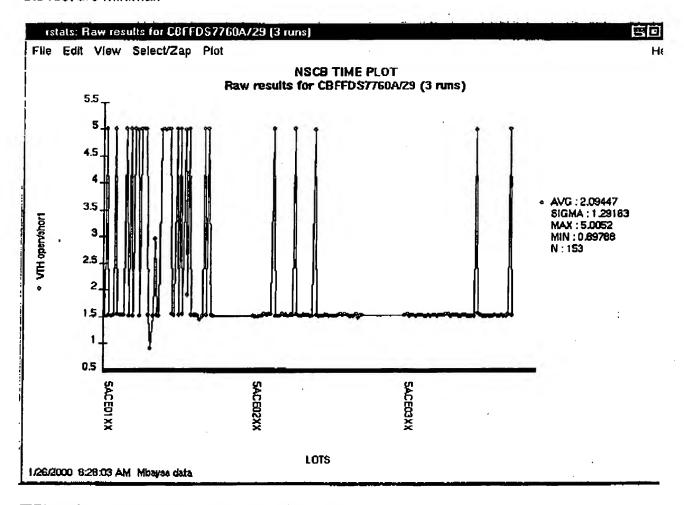
Below is the Vth plot for the open and short parameters. Data showed fallouts to be open with readings reaching compliance of 5V for all the lots. Lot 1 exhibited gross open failures while the rest are minimal.

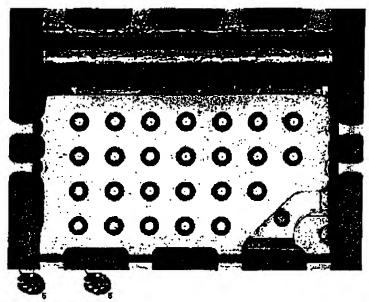
Further to the inputs that I have sent awhile ago, attached are the x-ray pictures which showed voids due to the gap between the die back and drain clip near the v-groove area. Thus the need to definitely have the optimize dispense tool design for the drain clip attach in time when the clipbonder arrives in FSC. (Note: The red bold dotted lines are the wetted portion of the die backside to the drain dip based on our interpretation on the x-ray results). Need your comments and suggestions. Thanks.
